TO: Parts & Service Managers

DATE: December 15, 2004

SUBJ: Ripley's Believe It or Not! Pinball Software Update

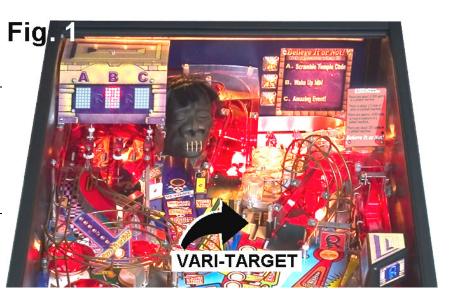
In the **Installs Menu** (see **Fig. 2**), if the "**X.HD**" (*Install Extra Hard*) **Icon** was selected, the symptom will occur (or via the **Adjustments Menu** (see **Fig. 3**), if Feature Adjustment 13 was changed to 31 or greater).

In the meantime, check Feature Adjustment 13 to ensure the setting is **30 or lower**, until the updated CPU ROM is installed. **Quick Fix:** Select the "**FACT**" (Install Normal) or "**HARD**" (Install Hard) Icons in the **Installs Menu** (reference your Ripley's Service Game Manual, Section **3**, Chapter **5**, Go To Installs Menu).
